Manhole Inspection Summary

Manhole # **S43G__050MH**

Insp Date: **6/3/08 9:06 AM**

Location Address: **203 s regester st**

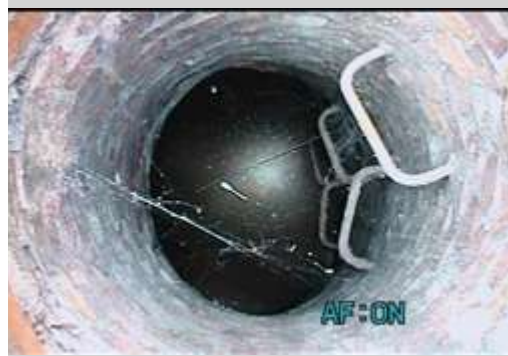
Top View

top view & steps

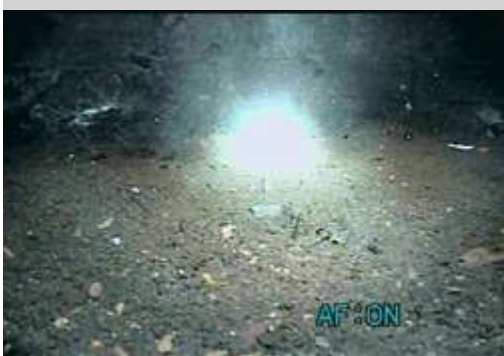
Defect 1

Condition: ☐ Sound ☐ Cracked ☐ Root Intrusion ☐ Deteriorated ☐ Leaks ☒ **Debris**

channel debris

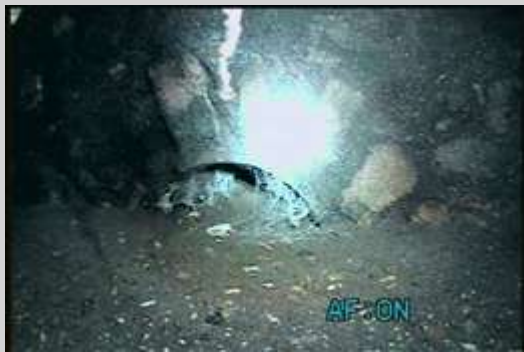
12 O'Clock Outflow

8 in. Circular Gravity Sewer
Pipe Out @ 12 O'Clock

Deposits: ☐ None ☐ Mud ☒ **Sludge** ☐ Debris ☐ Grease

Silt Depth: **6** (in.) Deposits Extent: **Heavy**
